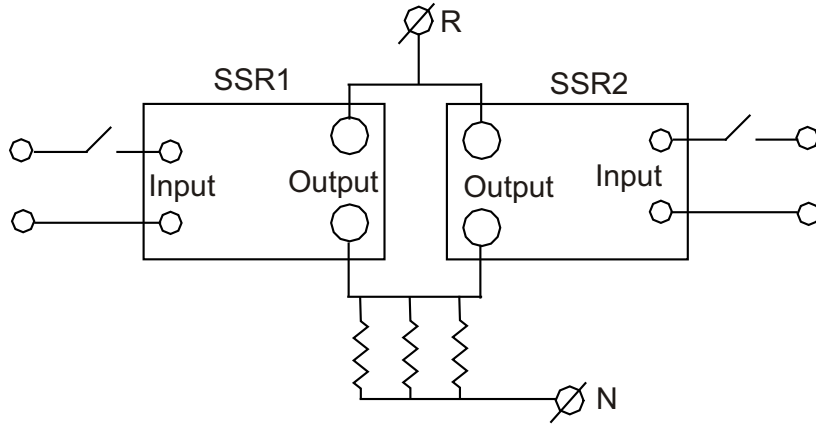
Wrong connection

Parallel the SSR not possible to increased the load current capacity

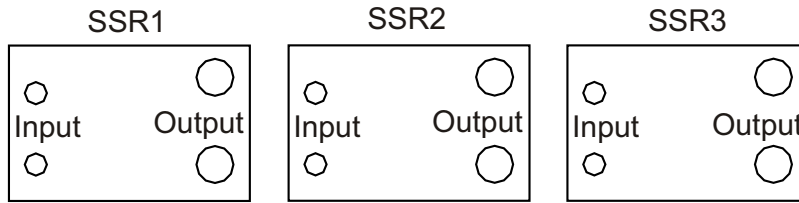
Wrong mounting of SSR due to I/P. DC - O/P. AC Very near
